**Flood Control Project Maintenance  
Levee Inspections**

**Fall 2018 Levee Maintenance Deficiency Summary Report**

**Sacramento River Basin**

**Flood Control Project Maintenance  
Levee Inspections****LMA District Cover Sheet****Fall 2018 Levee Inspection Results****Reclamation District No. 0003 Grand Island**

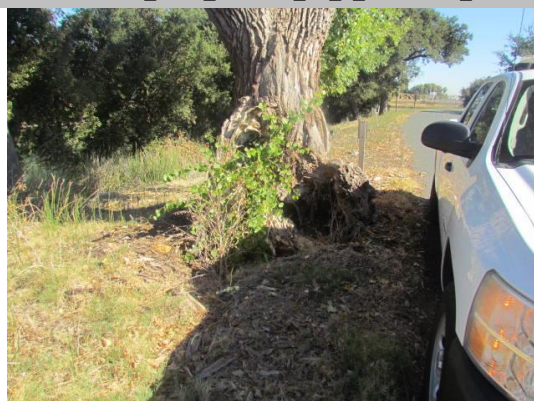
Looking at a hole next to oak tree on waterward shoulder.(2015)

Looking east at hole at base of tree on waterward shoulder. (2014)

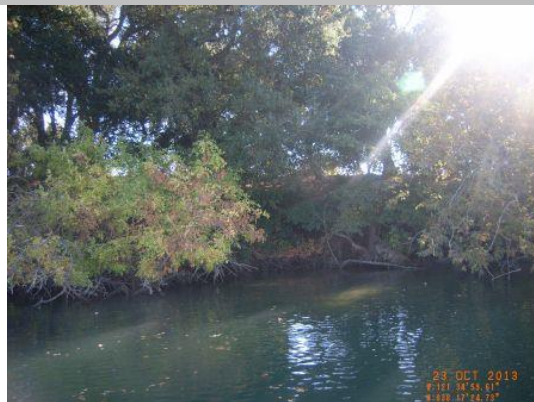
Photo 1 of 2 : FA\_2018\_RD0003\_24\_56\_20181023\_00153.jpg

2017 Site ID: STM 24.8 L  
Status: Eroding  
2018: Pockets of erosion that are deep into the levee toe that I would consider critical (Djulian).  
2017 Field Notes: New erosion at toe.  
Site History: 2008 - Area closed sign on bank. Newly fallen trees at both ends and pop outs along the bank. 2010 - Site extended downstream. 2011 - New erosion at the toe. More trees popouts. 2013 - Short vertical sections observed at the downstream end.

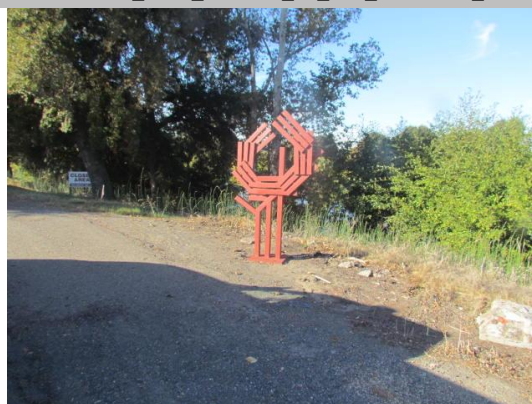
Photo 1 of 1 : FA\_2018\_RD0003\_24\_132\_20180925\_00085.jpg

Looking southwest at sign on waterward shoulder.

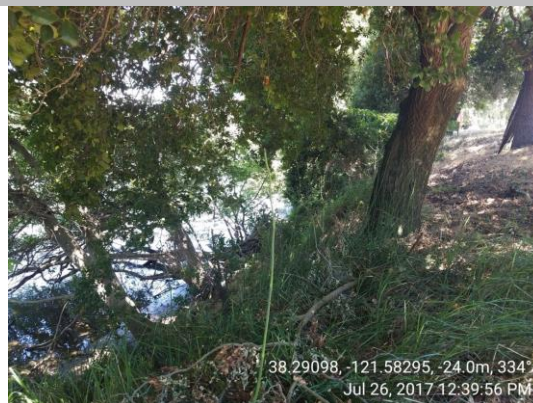
Photo 2 of 3 : FA\_2018\_RD0003\_24\_60\_20180925\_00045.jpg

LM Start	1.09	Rating **	A/W	Issue No.	60
LM End	1.10	Issue Type +	Ma	Location *	
Category	Supplemental			GPS Latitude/Longitude	
				Start	End
Item	2017 Storm Damage			38.290819 °	38.290706 °
				-121.582942 °	-121.582939 °
DWR ID	DWR_RD0003_01_f_2017_60				
Comment Code					
Inspector Comment					
Levee Evaluation Comments					
Description: District station 57+57 to 57+98, Sec. 18, 1. 5 N. R. 4 E., M.D.M. An erosion site exists along approximately 41 linear feet of the water side slope of Steamboat Slough (Unit 1). The erosion commences approximately 1/2 of the way down the slope from the crown to the waterside toe.					
Site ID No: 276					
Site Designation: LMA-102					
Repair Type: Erosion					
Rating: Area of Concern					
Field Date: 7/26/2017					
Notes:

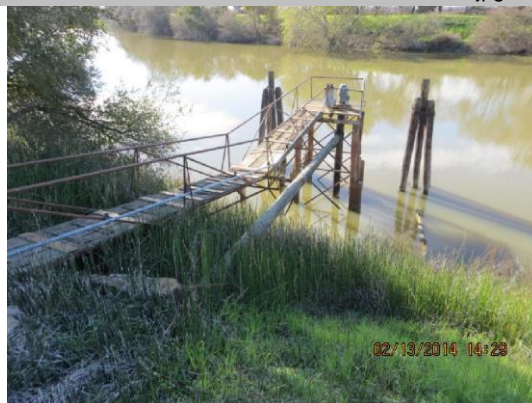
Photo 1 of 3 : UCIP\_FA\_2018\_31287\_57298.jpg

LM Start	1.32	Rating **	M	Issue No.	190	
LM End	1.32	Issue Type +	En	Location *		
Category	Supplemental			GPS Latitude/Longitude		
				Start	End	
Item	DWR UCIP Field Study			38.287515 °	38.287515 °	
				-121.582925 °	-121.582925 °	
DWR ID	24838					
Comment Code						
Inspector Comment						
FS_ID:31287 DS_ID:24838 EP_NO: N/A Repair Type: Non-Urgent Crossing Status: Found UCIP Comments: Appears abandoned and if so should be done so properly. FIELD_STRUCT_DESC: *ABANDONED* 2.5-inch galvanized iron irrigation pipe through the levee, 4 feet below the crown. 1.25-inch galvanized iron electrical conduit at the same location. FS Date: 2/13/2014

Walkway to pier on WS shoulder.

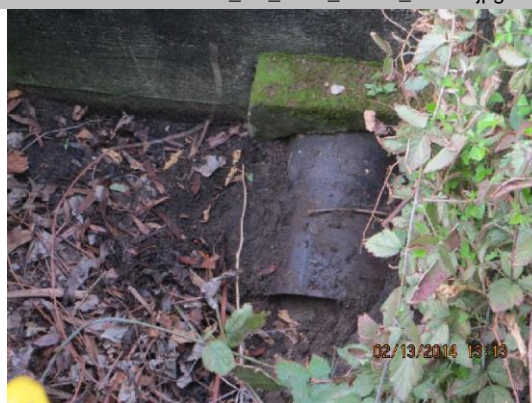
Photo 1 of 2 : UCIP\_FA\_2018\_29567\_54634.jpg

Pipe visible inside concrete distribution box on LS toe.

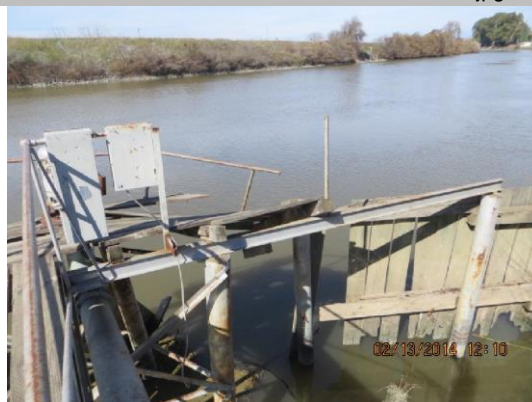
Photo 2 of 3 : UCIP\_FA\_2018\_29547\_54610.jpg

Damaged pump platform at WS toe.

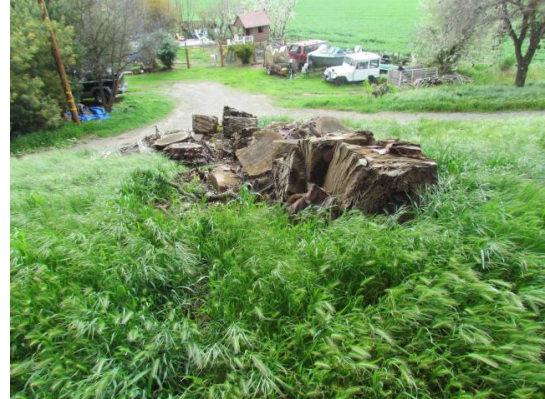
Photo 1 of 1 : FA\_2018\_RD0003\_24\_77\_20180925\_00064.jpg

Looking east at stumps on landward slope.

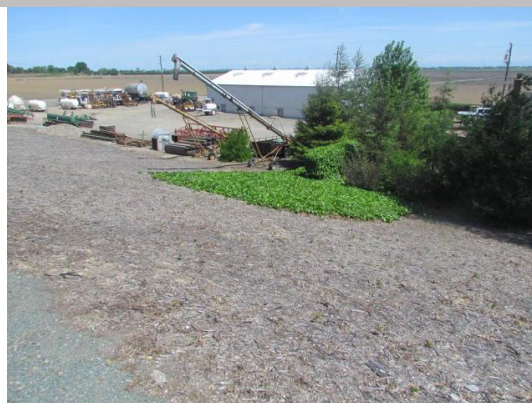
Photo 1 of 1 : FA\_2018\_RD0003\_24\_50\_20180925\_00032.jpg

Looking northeast at landscaping at lower half of landward slope and toe.

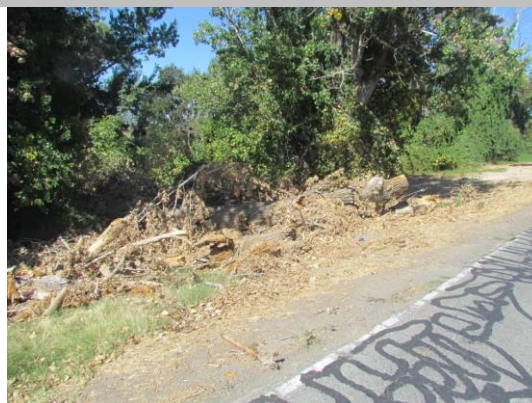
Photo 1 of 1 : FA\_2018\_RD0003\_24\_66\_20180925\_00051.jpg

Looking west at tree branches and limbs on waterward slope.

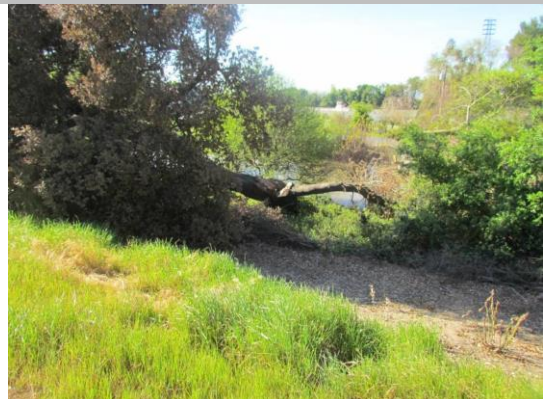
Photo 3 of 3 : FA\_2018\_RD0003\_25\_129\_20180925\_00090.jpg

Looking east at fallen tree on waterward slope.

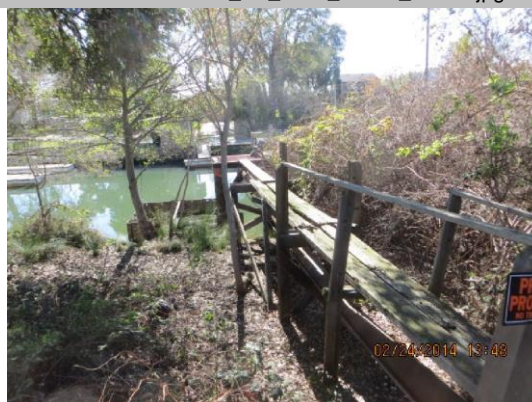
Photo 2 of 3 : UCIP\_FA\_2018\_31083\_56981.jpg

Pump on pier on WS slope. Wooden walkway failing.

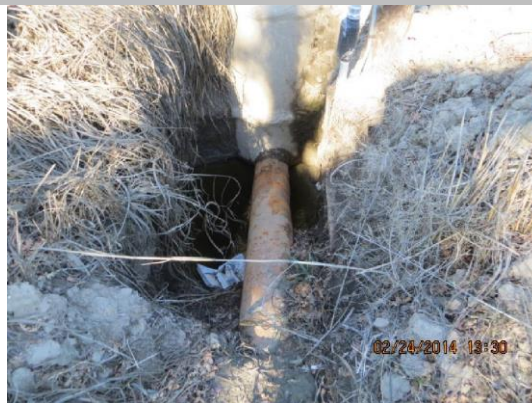
Photo 3 of 3 : UCIP\_FA\_2018\_31026\_56907.jpg

Trench excavated over pipe at Standpipe/LS toe.

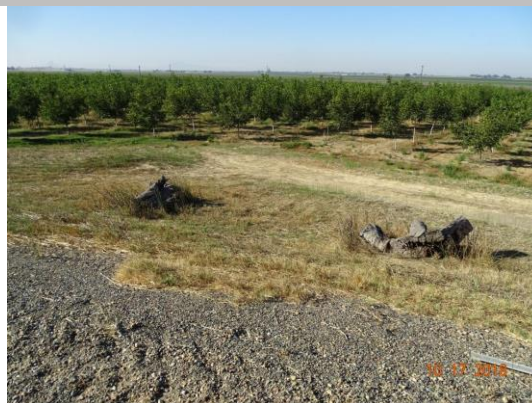
Photo 1 of 1 : FA\_2018\_RD0003\_25\_195\_20181018\_00297.jpg

View of logs on the land side slope (October 2018).

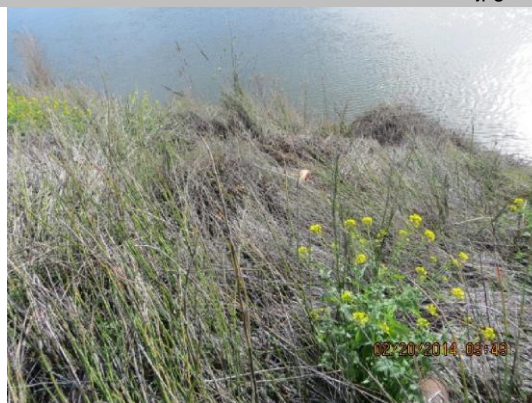
Photo 1 of 3 : UCIP\_FA\_2018\_30507\_56120.jpg

Pipe and pump covered by vegetation on WS slope.

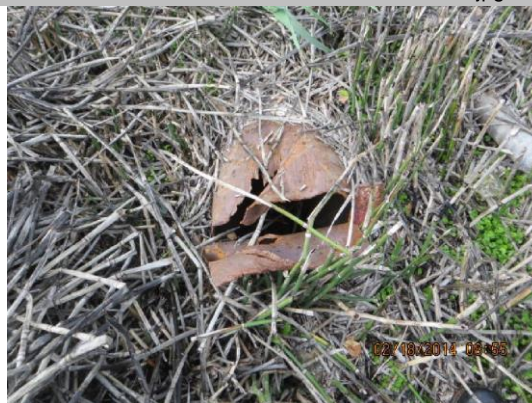
Photo 2 of 3 : UCIP\_FA\_2018\_41585\_55627.jpg

Pipe open on WS slope.

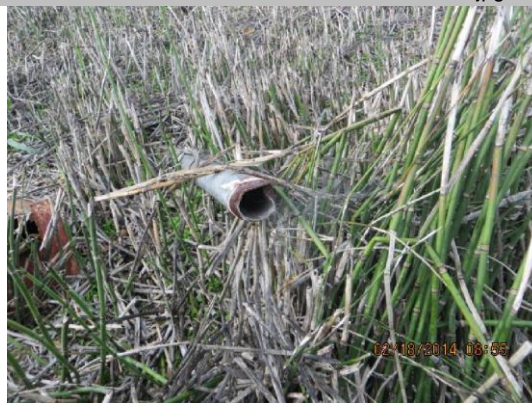
Photo 3 of 3 : UCIP\_FA\_2018\_30204\_55603.jpg

Pipe open on both ends.

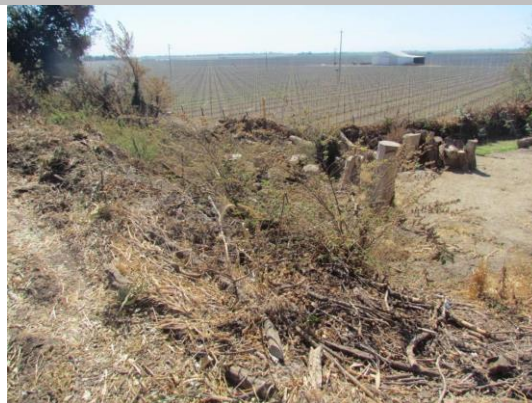
Photo 1 of 2 : FA\_2018\_RD0003\_25\_144\_20180925\_00115.jpg

Looking south at prunings on landward slope. (Fall 2016)
